1. Report No.	2. Government Accession No.	3. Recipients's Catalog No.	
4. Title and Subtitle  Inspection and Testing of Low Speed Vehicles		5. Report Date August 1998

6. Performing Organization Code NRD-23	
7. Author(s) Jeff Elias		8. Performing Organization Report No. VRTC-83-0461	
9. Performing Organization Name and Address National Highway Traffic Safety Administration Vehicle Research and Test Center P.O. Box 37 East Liberty, OH 43319		10. Work Unit No. (TRAI5)n code

14. Sponsoring Agency Code	
15. Supplementary Notes			
<p>16. Abstract</p> <p>In response to petitions by the golf cart industry the National Highway Traffic Safety Administration reviewed its position on low speed vehicles and has taken steps to define a new class of low speed vehicle (LSV) which is exempt from the federal motor vehicle safety standards (FMVSS) that apply to motor vehicles. A new safety standard, FMVSS 100, has been proposed to regulate this new class of vehicle.</p> <p>The Vehicle Research and Test Center conducted a survey and a series of tests to evaluate the safety and stability of LSVs. Two neighborhood electric vehicles, the Bombardier and the GEM, and one golf car, the Yamaha gasoline pow

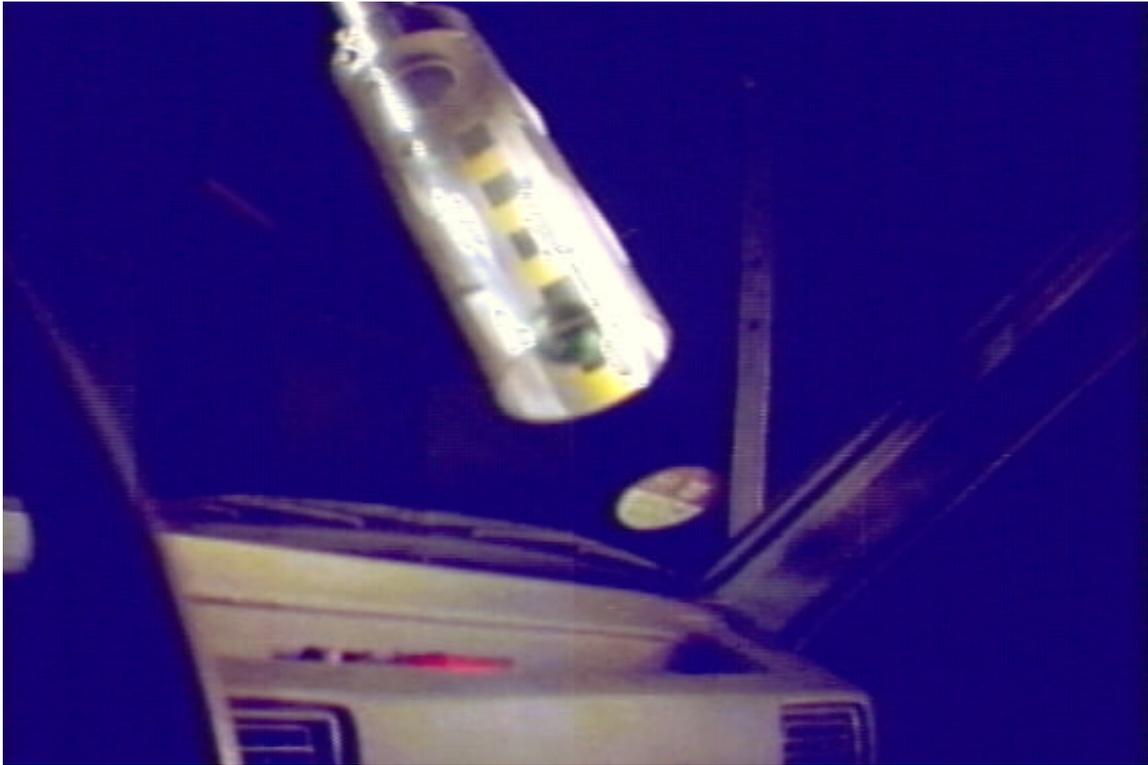
Figure 53 - Golf Ball Just Prior to Impact Into Windshield (**Time = 0 ms**)

Figures 53, 54, and 55 are a series of images captured from the high speed digital camera recording of the 125 mph test. Figure 53 is an image of the golf ball in flight just before impact into the windshield of a 1985 Toyota Corolla. Figure 54 is 10 milliseconds later, showing the shower

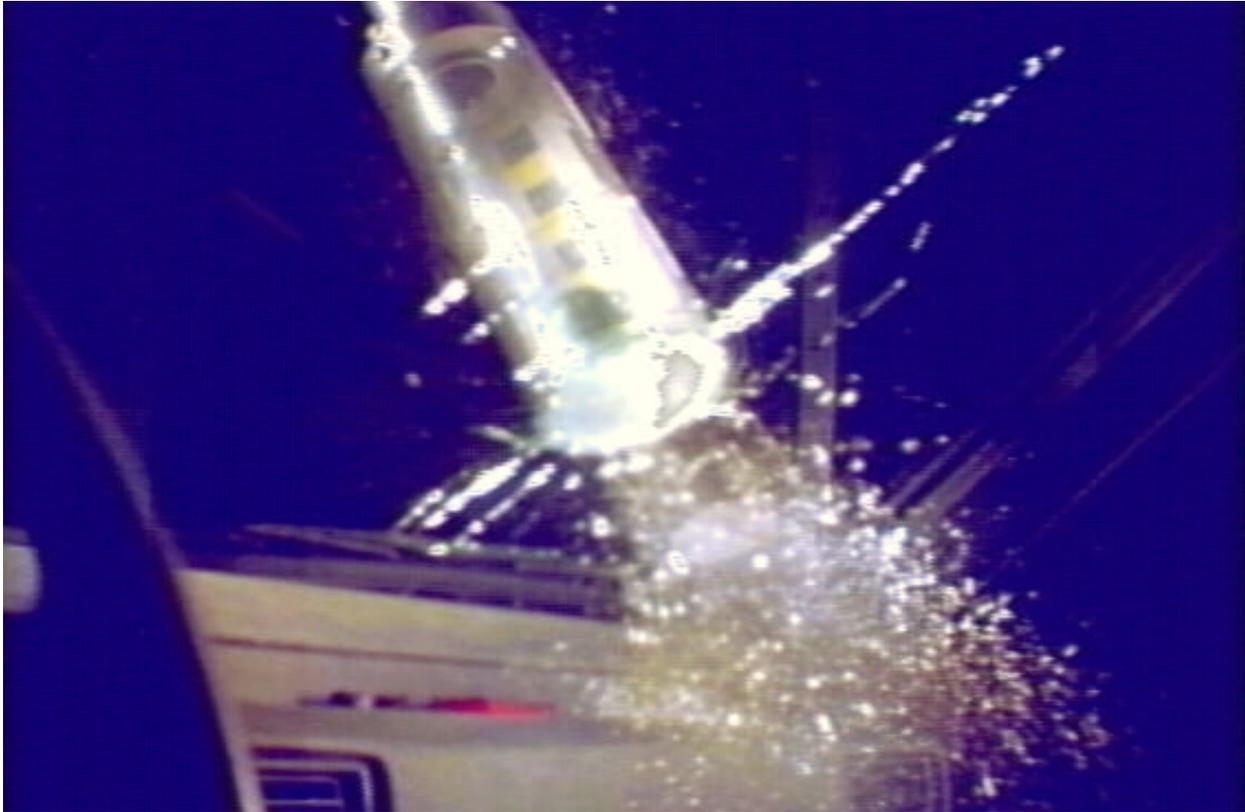
Figure 55- Post Impact - Expanding Spray and Particle Size Distribution (Time = 20 ms)

of ejected glass particles spraying from the back surface of the windshield into the passenger compartment. Figure 55 is an additional 10 milliseconds into the impact showing the expanding spray of glass particles which ranged in size from 2-3 mm down to a pulverized dust like size. The gold ball did not penetrate the glazing.

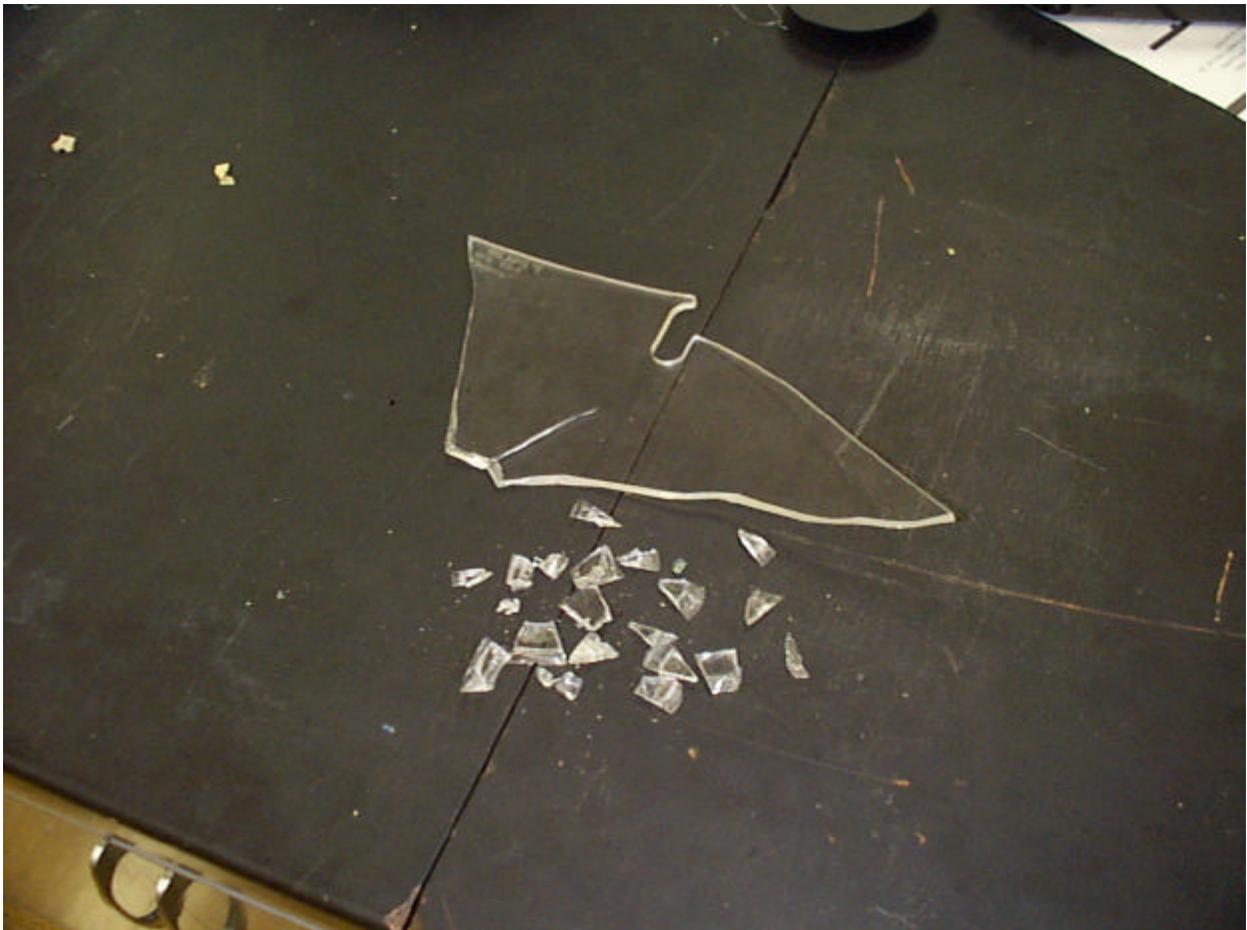
Figure 56- Fragments From Motorcycle Windshield Test

This windshield, which was an acrylic plastic, had a measured thickness of 0.1808 inches. The impact test was run at approximately 120-125 mph. The results of these tests are documented in Figures 56 and 57.

The windshield split into four major segments and shattered into a number of fairly large fragments at the point of impact, allowing the golf ball to penetrate. Figure 56 is a photograph of the fragments collected. The smaller fragments ranged in size from about ½ inch down to **C** inch or less in width. Figure 57 shows a post test photograph of the windshield with the gas cannon still in position. The edges of the windshield and windshield fragments were irregular (jagged) and formed relatively sharp cutting edges, although not as sharp as typically seen with glass.
